Reducing FOG with Bioaugmentation

FOG formation, accumulation and consequences

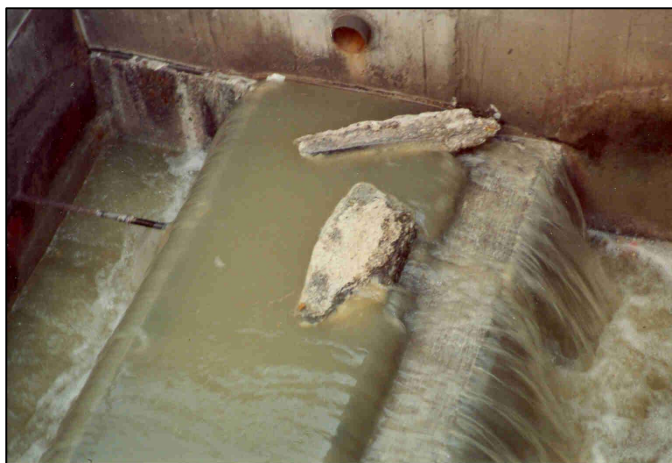
Figure 1: Floating pieces of FOG at the effluent of the grit chamber of a wastewater treatment plant.¹

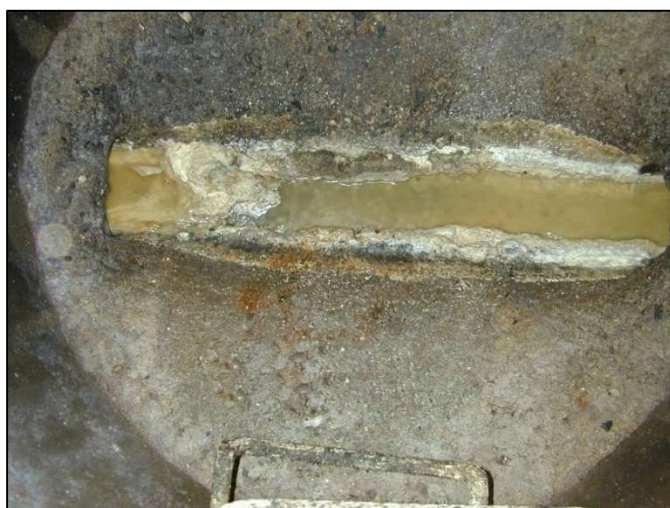
Figure 2: Looking down into a manhole one can see significant buildup of FOG on the lateral line from a commercial establishment. The lateral connects the business to the sewer system. One can also observe corrosion to the concrete as well as the metal steps (bottom of photo).

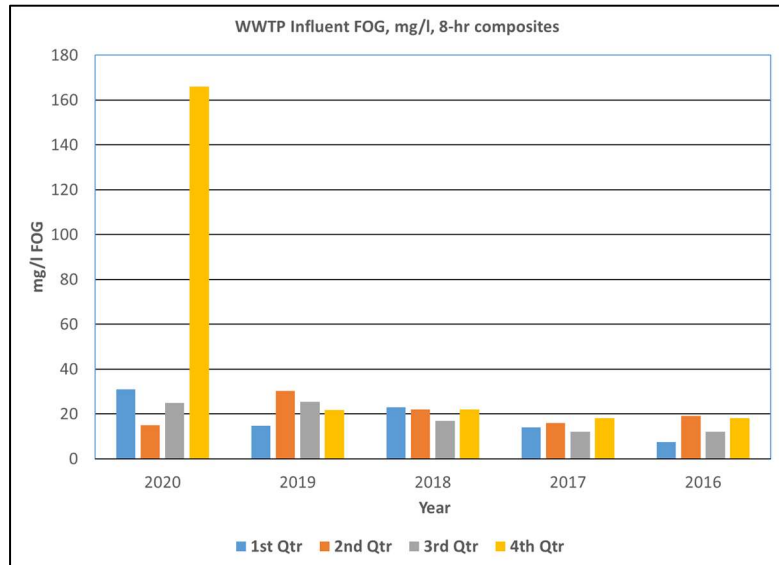
Figure 3: Data plotted over a 5-year period illustrate the FOG concentration is relatively consistent year to year and quarter to quarter. However, the 4th quarter of 2020 shows a significant spike. Utility managers are uncertain of the cause. The utility's pretreatment coordinator said no change in flows could be detected from commercial business.

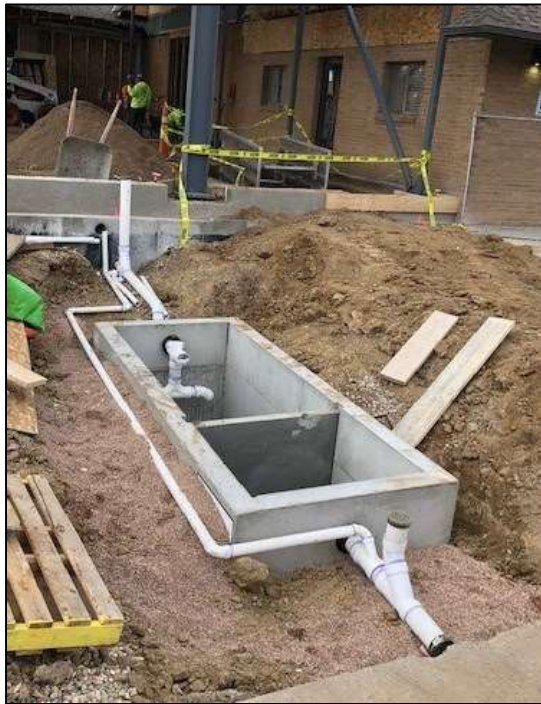
Figure 4: A new grease interceptor (GI) being installed at a restaurant. A multiple chamber design with a baffle(s) between the chambers is common. The design is such that FOG floats to the surface in the first chamber while the liquid phase goes under the baffle wall. Remaining FOG then floats to the surface of the second chamber. There is typically a baffle or other arrangement to prevent the floating FOG to leave the second chamber. The liquid phase will be drawn from the bottom.

It is common practice to attempt to maintain the FOG at no more than 25% of a GI's total volume. So, when 25% full of FOG both the FOG and liquid are pumped from the tank by a commercial hauler.

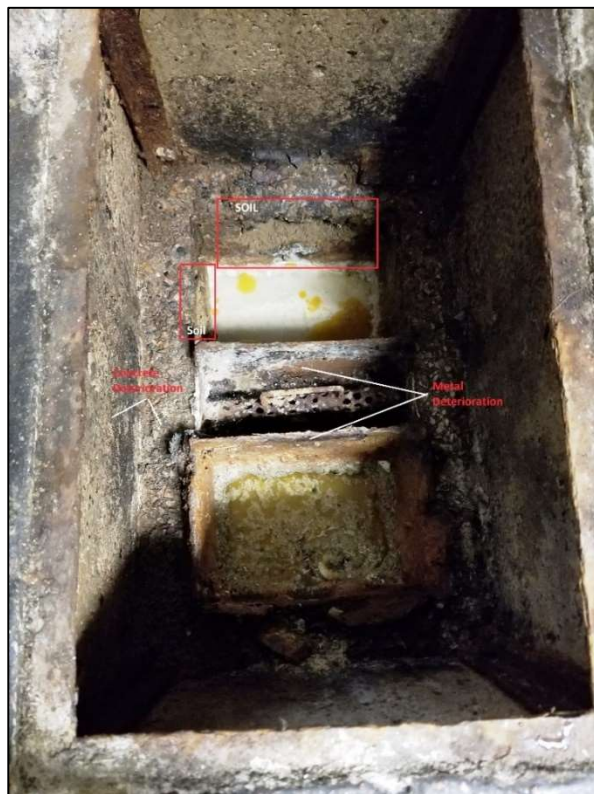
Figure 5: Grease interceptor (GI) exhibiting significant damage due to the corrosive nature of FOG. Top center one can see exposed soil where the concrete is missing. One can also observe extensive damage to the concrete parts of the structure to the left of the picture. In the middle of the photo observe the lines indicating areas of significant corrosion to exposed metallic parts.

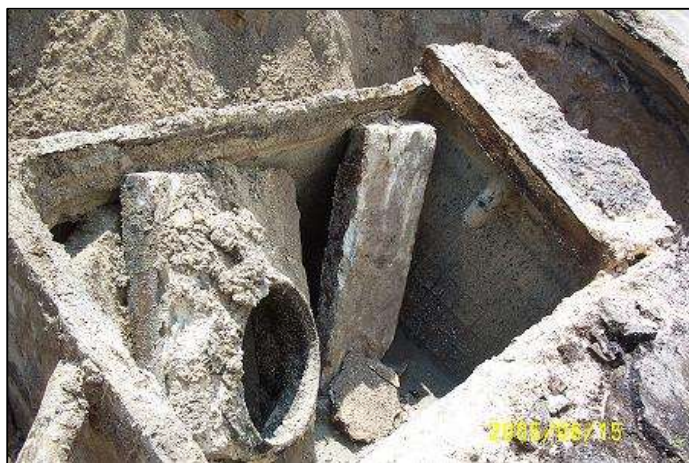
Figure 6: Grease interceptor completely collapsed due to corrosive effects of FOG.

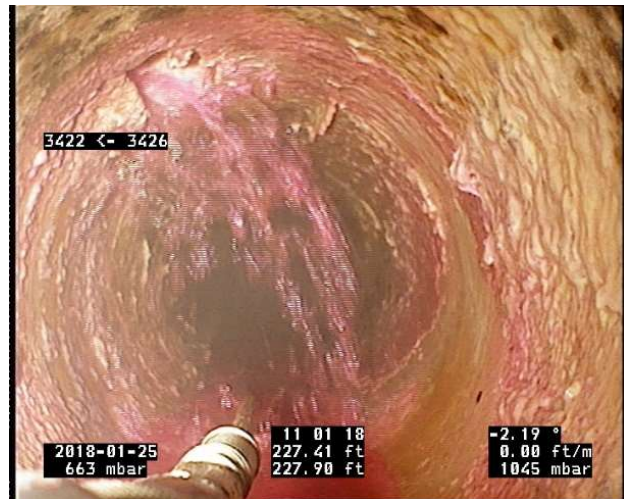
Figure 7: Utilities sometimes use dye to identify the source of undesirable FOG. Here a red dye injected at the business clearly identifies it as the source of the problem.

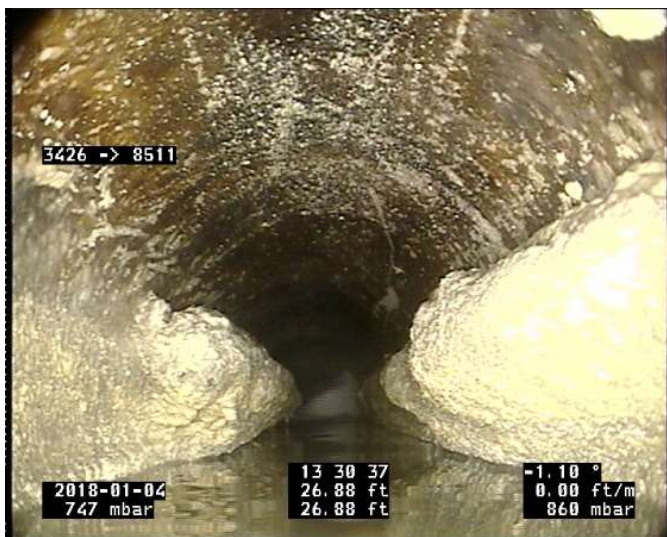
Figure 8: The image of the substances as they go down the drain is significantly different from what is observed in the sewer. One sees large masses of deposits that appear to be more “soapy” than oily or greasy.

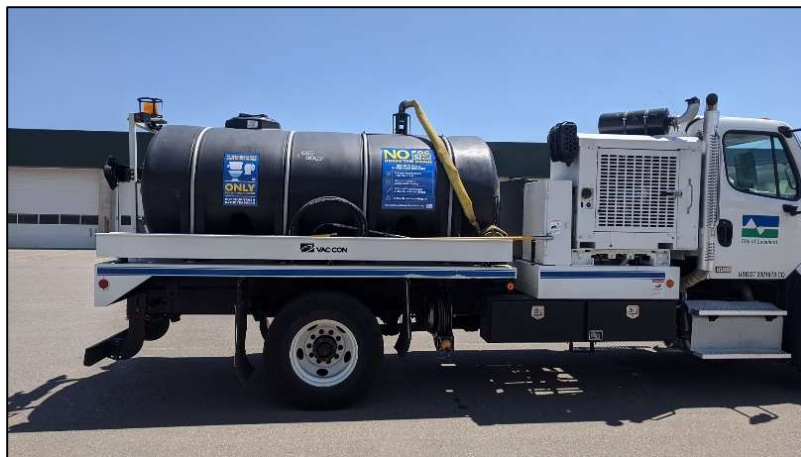
Figure 10: Jet truck ready for deployment to clear sewer lines of FOG and other solids. Note again the signs used to promote public awareness.

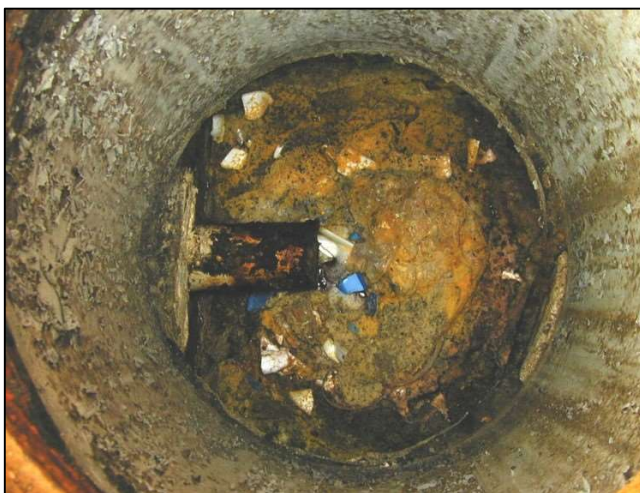
Figure 11: Most commercial establishments that discharge FOG are required to install and maintain a 'grease trap' or grease interceptor (GI). One can see here a poorly maintained GI containing not only FOG but also waste such as plastic and paper cups and other debris that has no place in a sanitary sewer system.

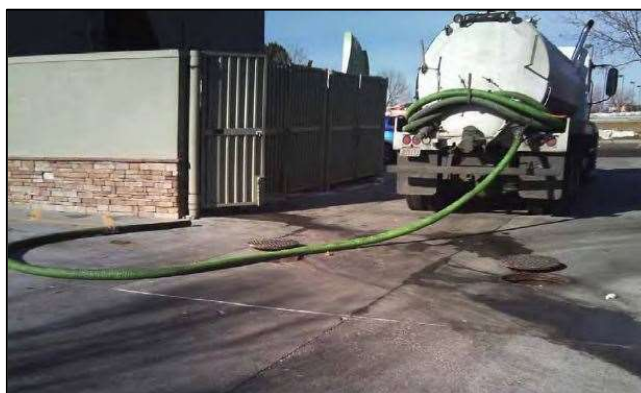
Figure 12: GI tanks and vaults have to be maintained and periodically emptied as is pictured here with a commercial hauler preparing to pump out and haul off the grease. If clean, the grease may be sold to make other products, e.g. biodiesel. Obviously, contents of GI tanks contaminated by other debris are not suitable to recycling.

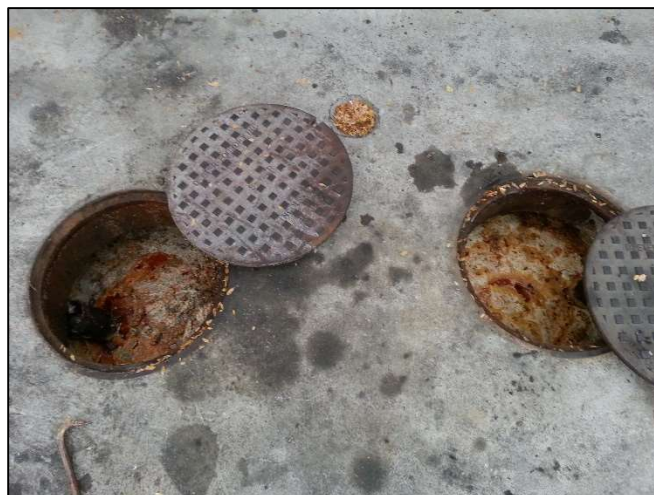
Figure 13: Both sides of a GI vault exceed the recommended 25% of volume for FOG. The tank is in need of maintenance. The owner of the business is responsible for installation and maintenance of the GI as well as the lateral connecting the outlet of the GI to the sewer. Delaying or ignoring proper maintenance of the GI and lateral will lead to significant remediation costs.

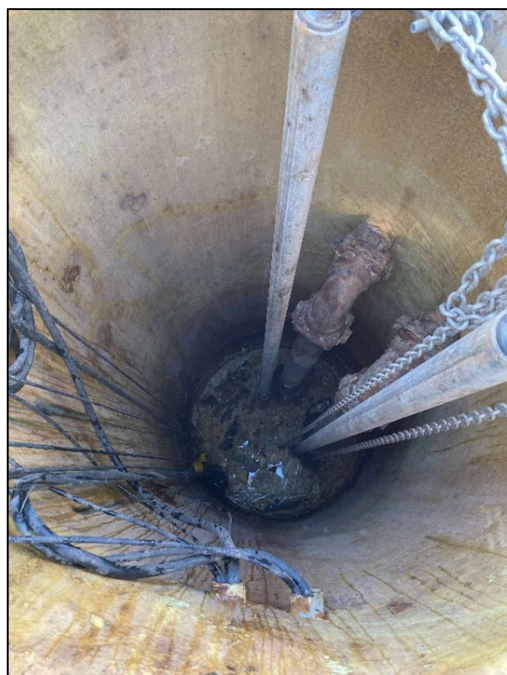
Figure 14: Removing FOG from collection infrastructures is essential for wastewater management. Lift stations that move wastewater with heavy grease loads require frequent cleanings to stay operational. Additionally, to avoid sanitary sewer overflows, collection pipes are often jetted to remove FOG buildups. The above maintenance precautions are labor intensive and costly for wastewater utility entities. Photo courtesy Kathy Kelly. BioLynceus®.

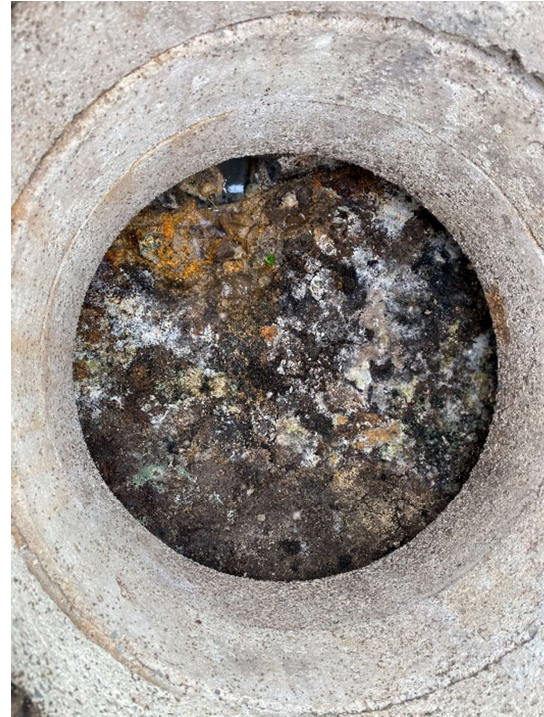
Figure 15: A view into this manhole exhibits a substantial amount of FOG that will soon create more serious problems and costly resolution. Bioaugmentation applied now can save significant money and effort down the road. Bioaugmentation is the preventative maintenance alternative to brute force. Photo courtesy Kathy Kelly. BioLynceus.

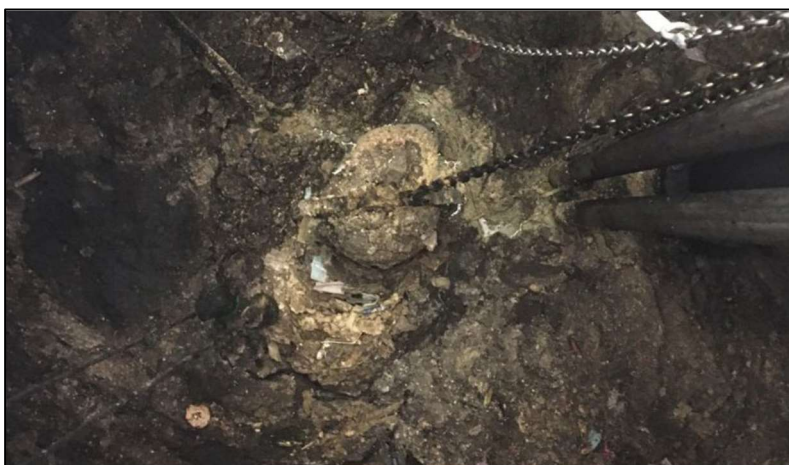
Figure 16: Severe build up at the lift station created significant maintenance and cleaning costs.

One sewer line, particularly prone to FOG buildups, was receiving wastewater inputs from a concentrated cluster of restaurant establishments. The pipe required monthly jetting to maintain flow. Additionally, the down-line lift station frequently needed cleaning. The wastewater managers tried using a citrus based product to dissolve the grease. However, the citrus degreaser did little to remove FOG and caused additional corrosion to the cables and floats in the lift station. The operations management needed an effective solution to reduce the frequency of collection system maintenance.

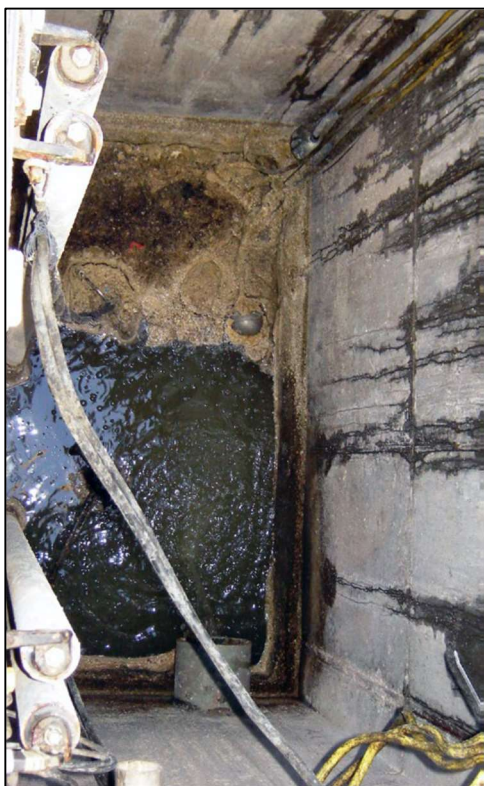
Figure 17: The lift station prior to treatment with PBII. FOG and precursors were dark colored and difficult to remove. Degreasers being used had only limited effectiveness. Photo courtesy Mark Sembach, BioLynceus.

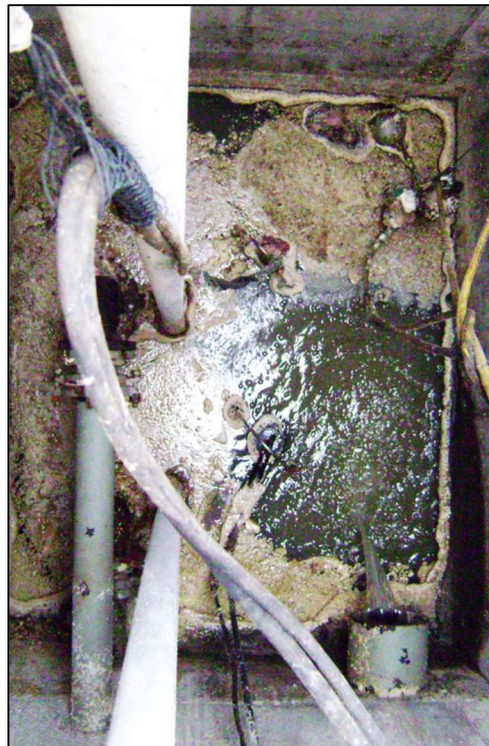
Figure 18: The city's lift station one month after beginning treatment with PBII. There were fewer solids in the lift station. Solids were now lighter in color and softer in texture so were easier to remove. Photo courtesy Mark Sembach, BioLynceus.

Within the first month of treatment, the operators noticed a considerable improvement in the amount of FOG collecting in the lift station and it was also a lighter color and softer in texture.

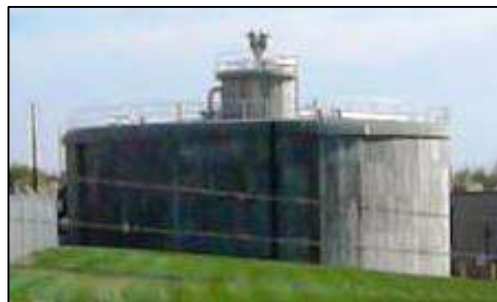
Figure 19: A side benefit of treating the collection system with PBII, was the quantity of solids that needed to be removed from the anaerobic digester decreased.

The solids mass dried and vacated (SMDV) from the anaerobic digester was reduced by 31% in the first year. In the second and third years of treatment, the SMDV was decreased by 14% and 61%.

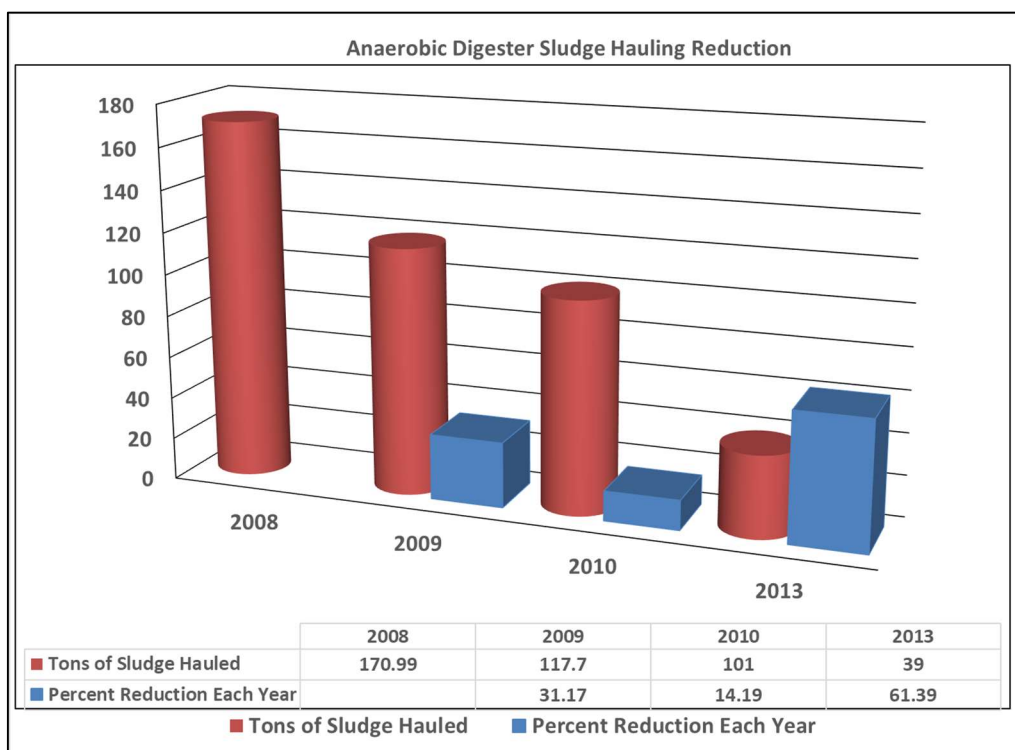
Figure 20: Using Probiotic Scrubber II to remove accumulated solids and FOG in the collection system paid an additional dividend. Anaerobic digester solids also decreased. This was noted after the first year of treatment. By the fourth year of treatment digester solids had decreased over 61% resulting in significant savings.

By reducing biosolids in the digester, bioaugmentation helped the facility save over \$20,000 in removal fees in the first year. Improving biological solids degradation at the mechanical plant reduced the financial burden of wasted solids hauling and disposal.

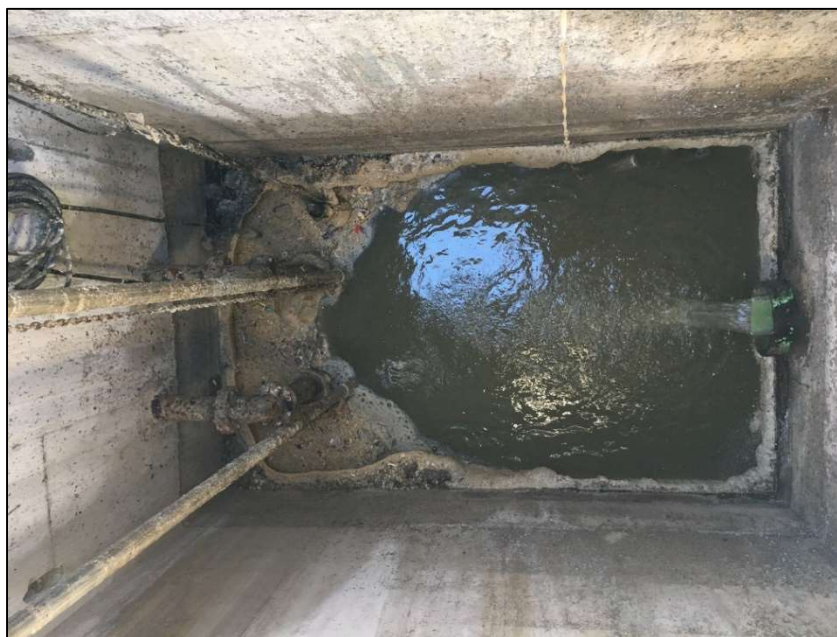
Figure 21: The lift station before starting treatment with PBPP. Notice the FOG coating the walls and 'climbing' the piping and chains. Photo courtesy Herb Fancher, BioLynceus.

During the summer of 2020 they noticed considerable buildup of FOG at the lift station and there was visible oil sheen around edges of the lagoons. The town manager reported, "while inspecting the new lift station we noticed the FOG was climbing the walls and other parts of the lift station."

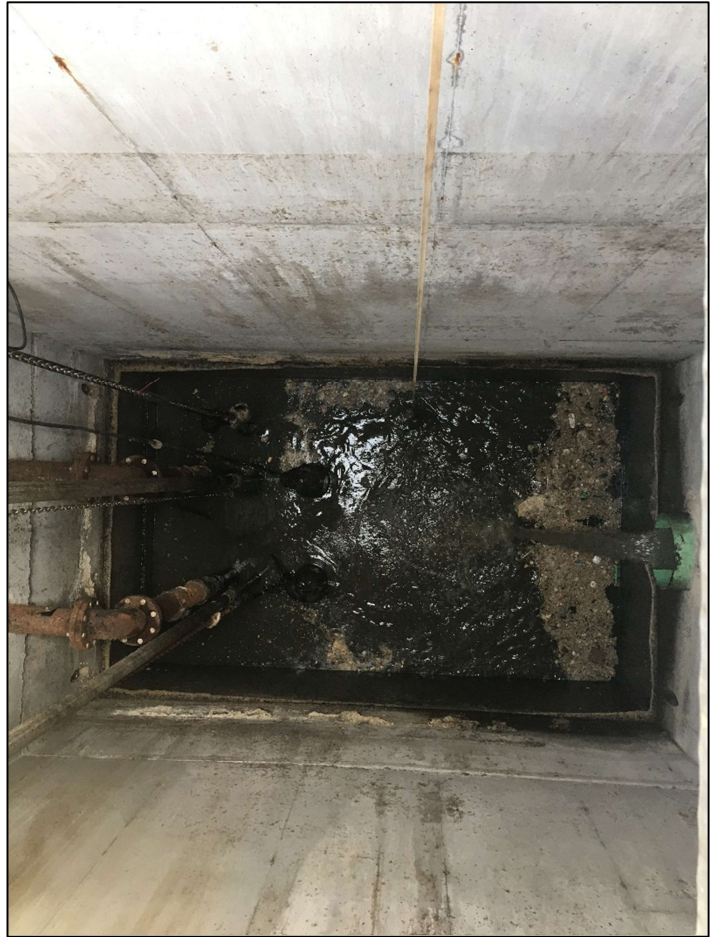
Figure 22: After 3 months of treatment with PBPP the lift station equipment structure and equipment were virtually free of FOG buildup as can be clearly seen in the photograph. Photo courtesy Herb Fancher, BioLynceus.
